File Ref. No: BFS16/1986 (0082)
TRIM Ref. No: D18/5317
Contact: Station Officer Paul Scott

16 February 2018

**Re: INSPECTION REQUEST
ANCHORAGE ISLANDS
167 MARINERS DRIVE WEST TWEED HEADS (“the precinct”)**

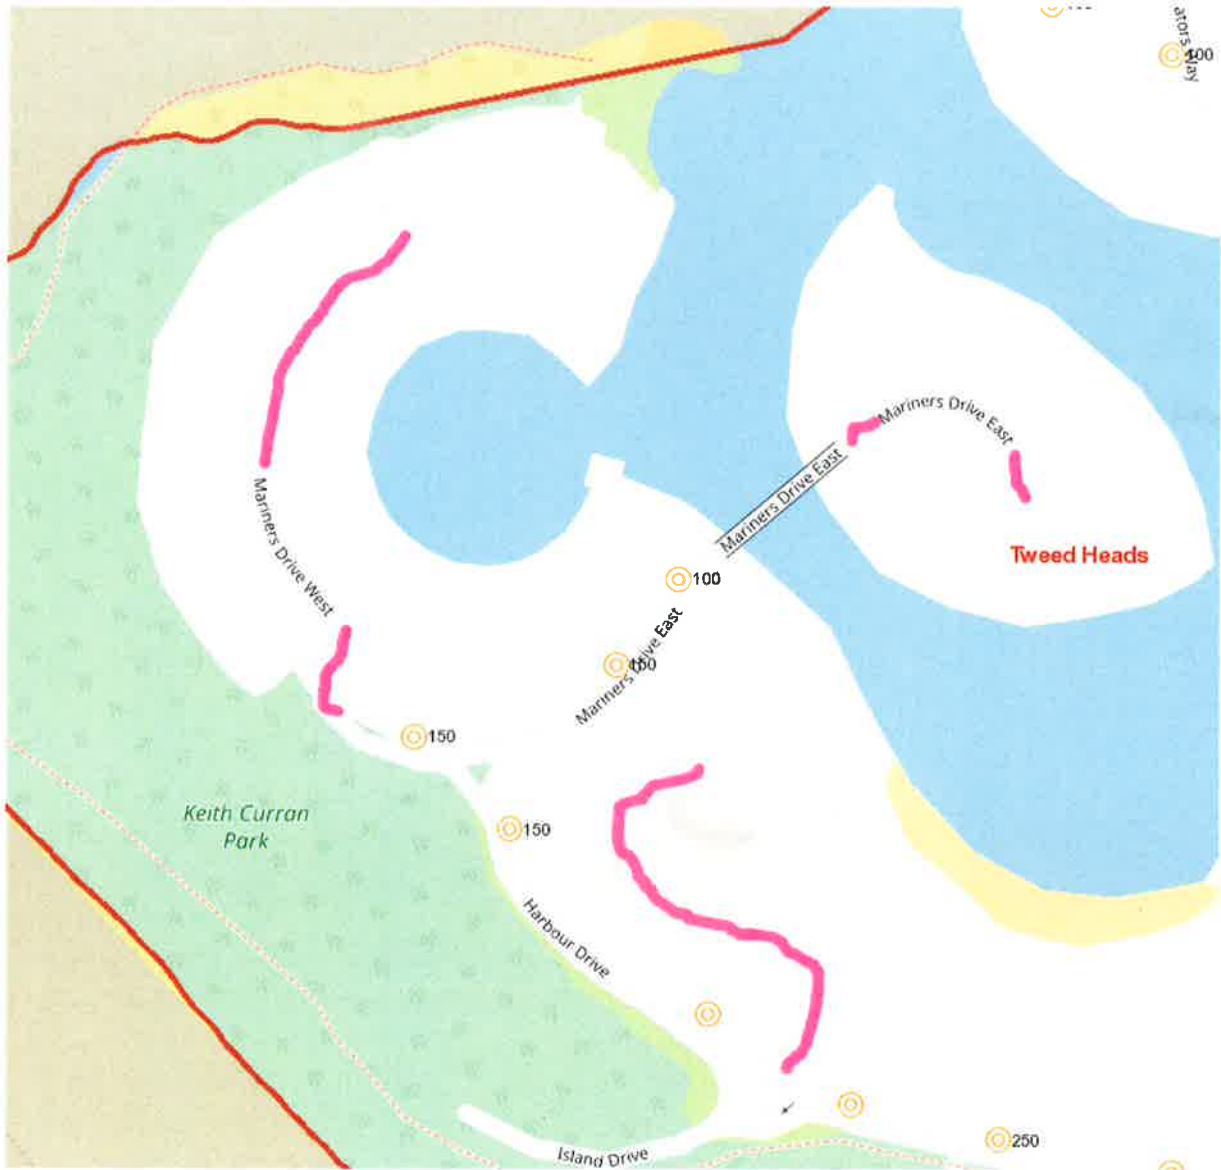
Attachment 1.

- Hydrant coverage at the site had been reduced due to the removal of a hydrant.

- a. This gated estate had 4 hydrants along the pathway/roadway with very poor water pressure at the end of the road, probably not enough to use 2 x 38mm hoses simultaneously. There was no hydrant booster at the start of this road.

- a. There was only one hydrant located in this street, at the very end of the development (it was covered in earth and still had the cap on it). This one hydrant had very good water pressure.

- a. There were no hydrants in the access road for this estate.

Map showing fire hydrants on the reticulated water main (double circle) and affected streets highlighted by purple line.

Therefore, on behalf of the Commissioner of FRNSW, Council is requested to inspect 'the precinct' in accordance with the provisions of Section 119T (6) of the *Environmental Planning and Assessment Act 1979* (EP&A Act).
