# Sediment Clean-up Closeout Report

Unnamed tributary to Hopping Dicks Ck, TYALGUM

Lot 127/DP755724,

20 April 2015

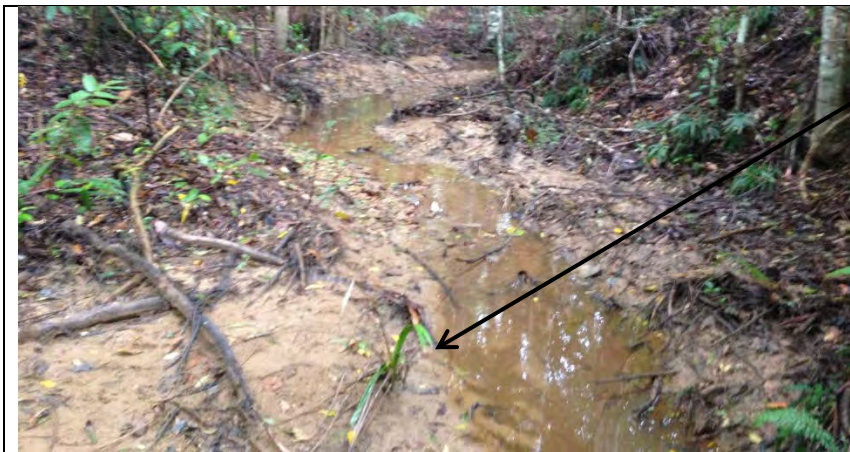
| | <p><b>Pic 2</b> – Channel is naturally re-incising. Lomandra colonising in remaining sediments</p> |

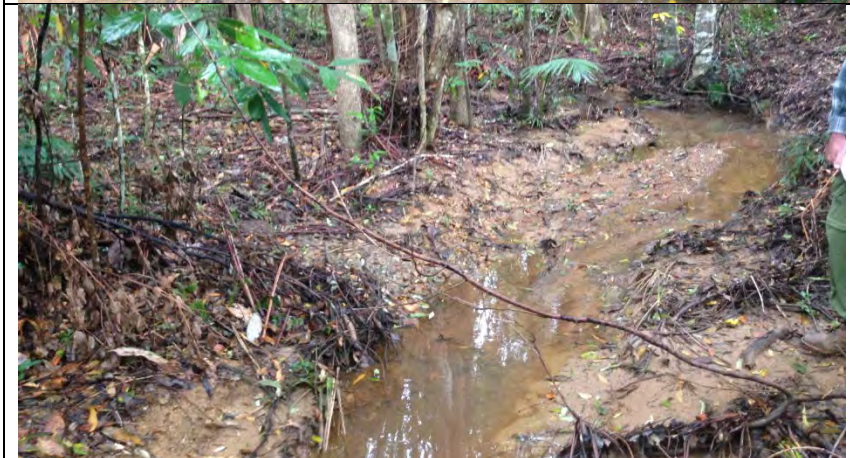
| | <p><b>Pic 3</b> – Channel re-incising to an equilibrium</p> |

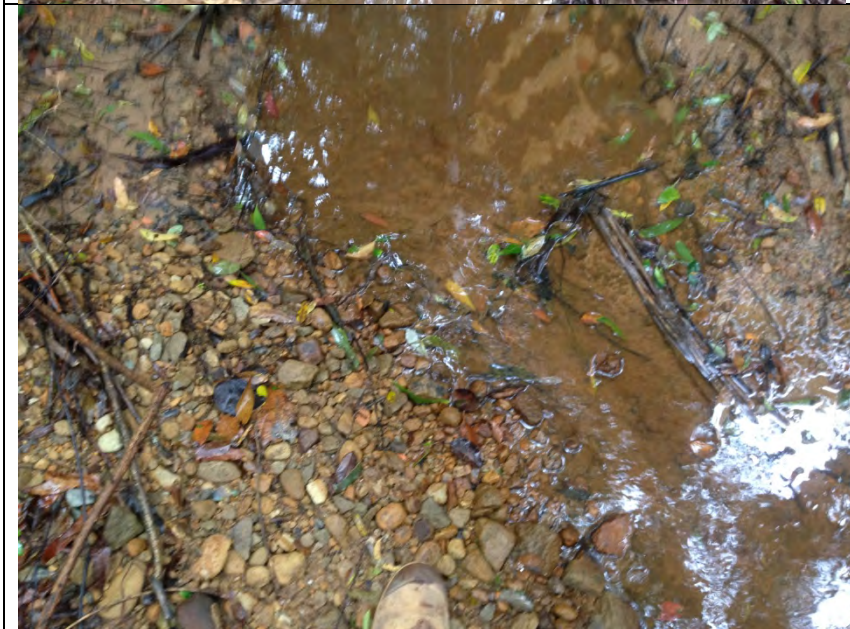
| | <p><b>Pic 4</b> – Sediment has been scoured back to natural bed materials in higher energy areas</p> |

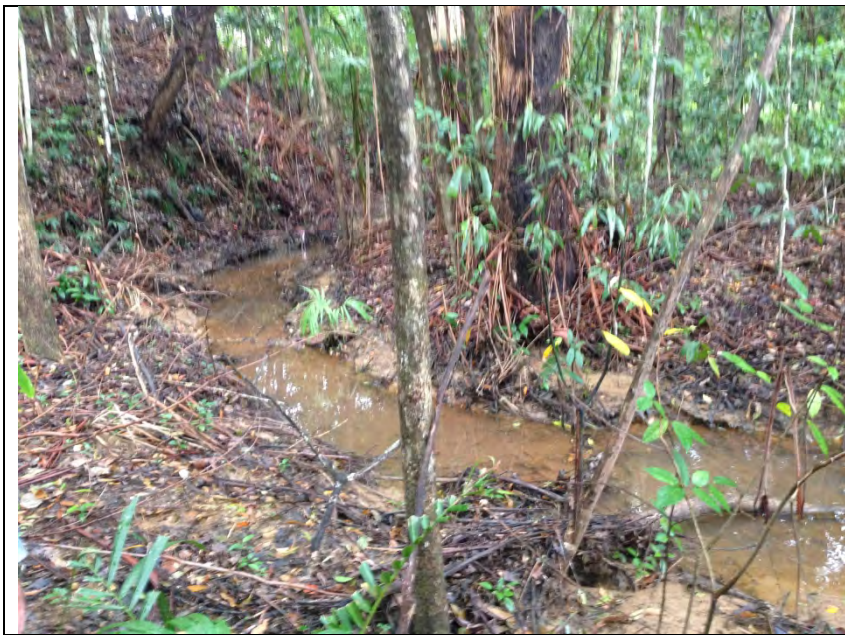
**Pic 5** – Channel incising, remaining depositional sediments incorporated into surrounding areas.

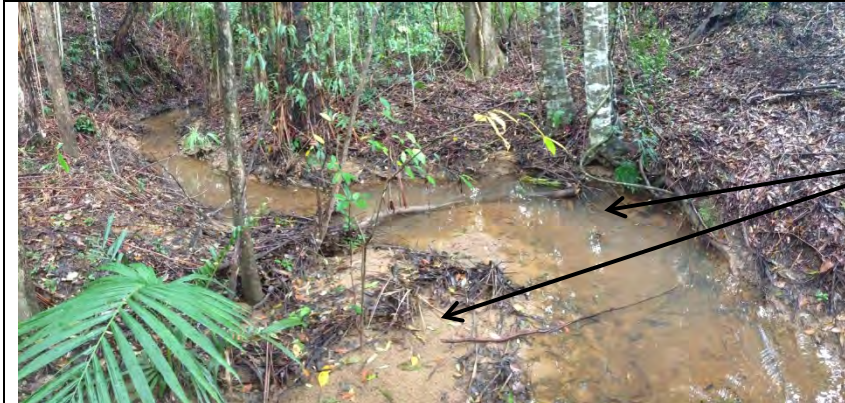
**Pic 6** – Channel naturally adjusting – scour on outside bends, depositional bars on inside.

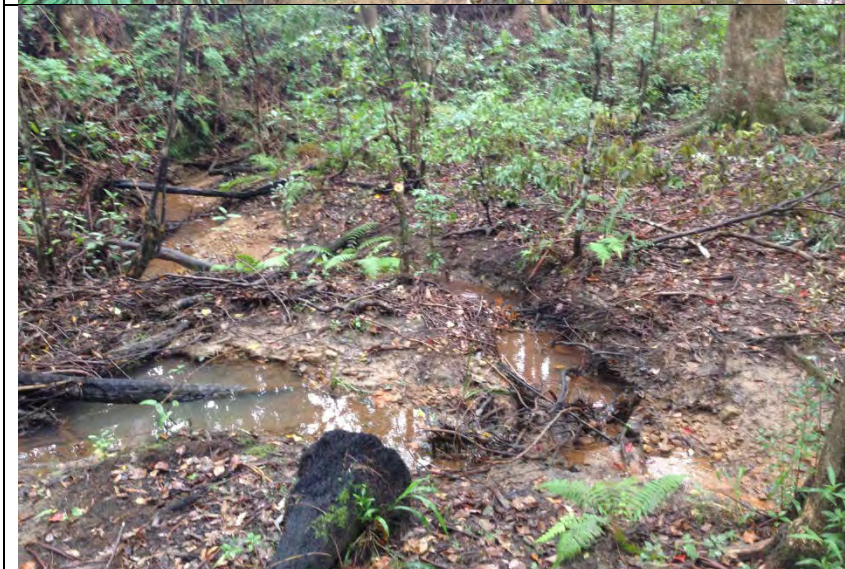
**Pic 7** – Upstream section, channel scoured back to natural levels.

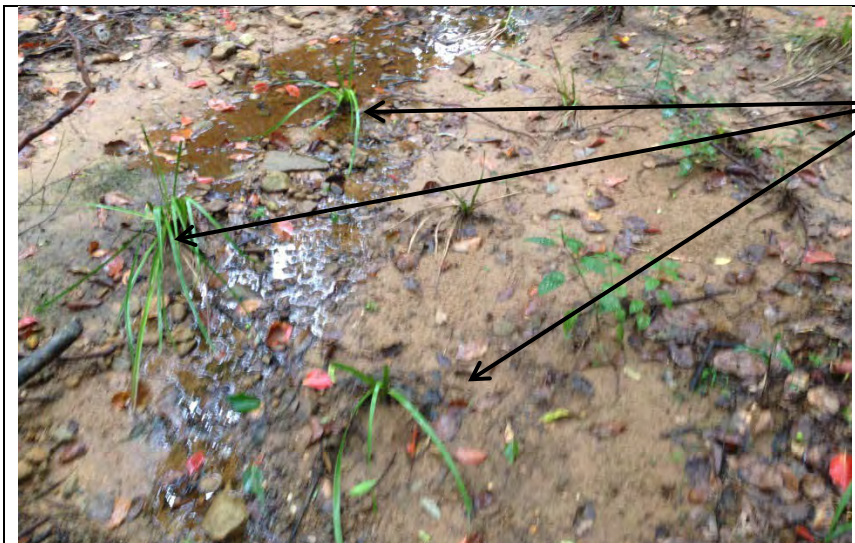
| | <p><b>Pic 8</b> – Lomandra colonising in sediments</p> |

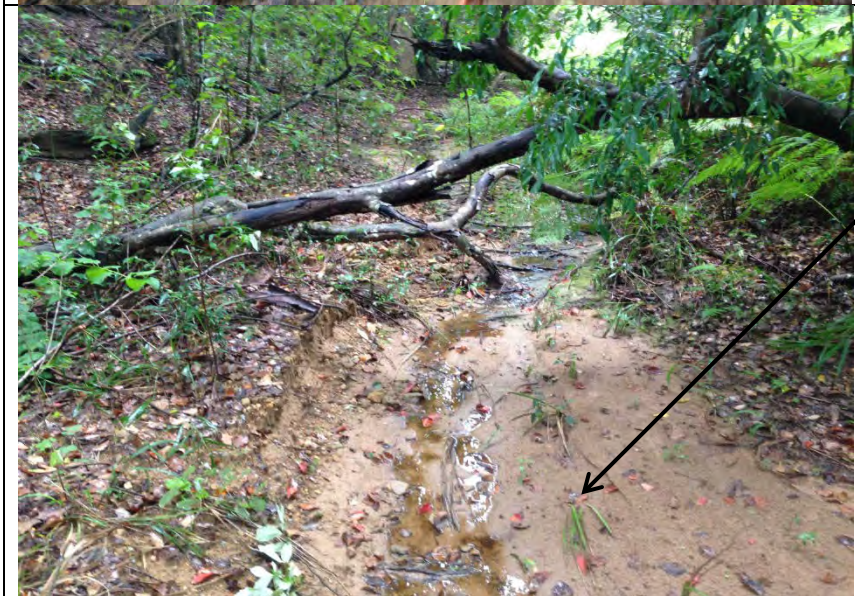
| | <p><b>Pic 9</b> – Lomandra colonising in sediments</p> |

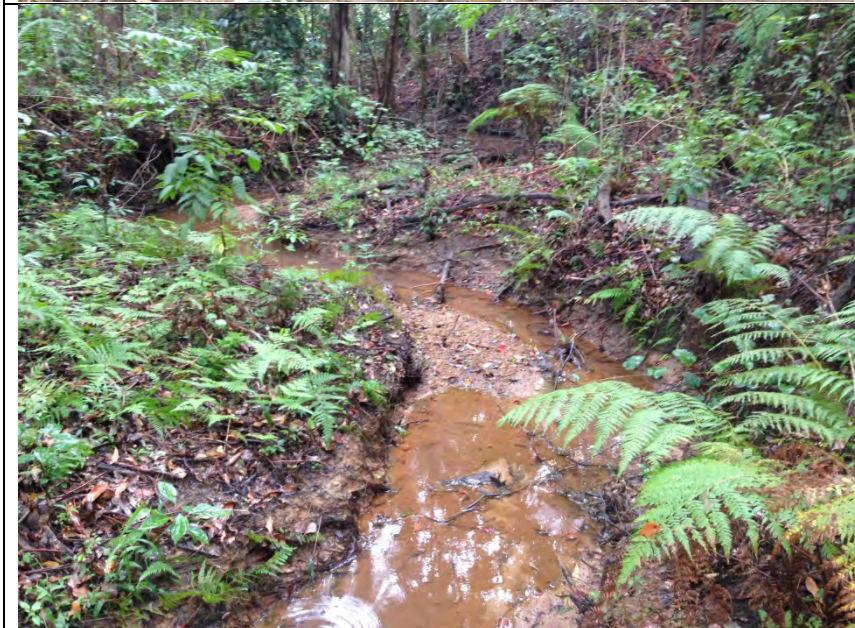
| | <p><b>Pic 10</b> – Channel re incised to natural formation.</p> |
