# **Tweed Shire Council**

**Bogangar Rugby League Sports  
Fields**

**Recycled Water Management  
Plan**

**October 2007**

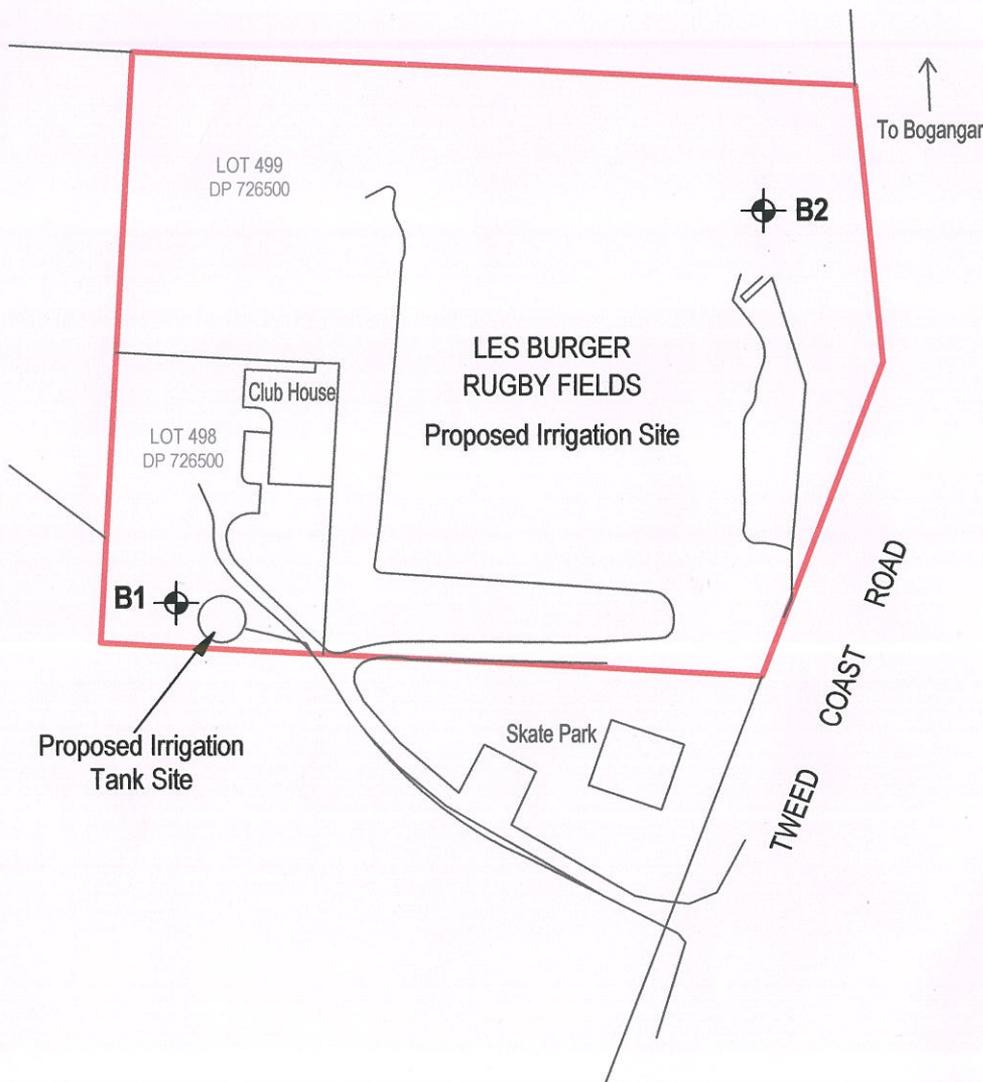
**LOCALITY PLAN AND TEST LOCATIONS**

TWEED COAST ROAD, BOGANGAR
