**Coastal Hazard Lines Map**  
 Figure 1.15  
 Sheet 15 of 26

**TWEED DEVELOPMENT CONTROL PLAN**  
**Section B25 Coastal Hazards**

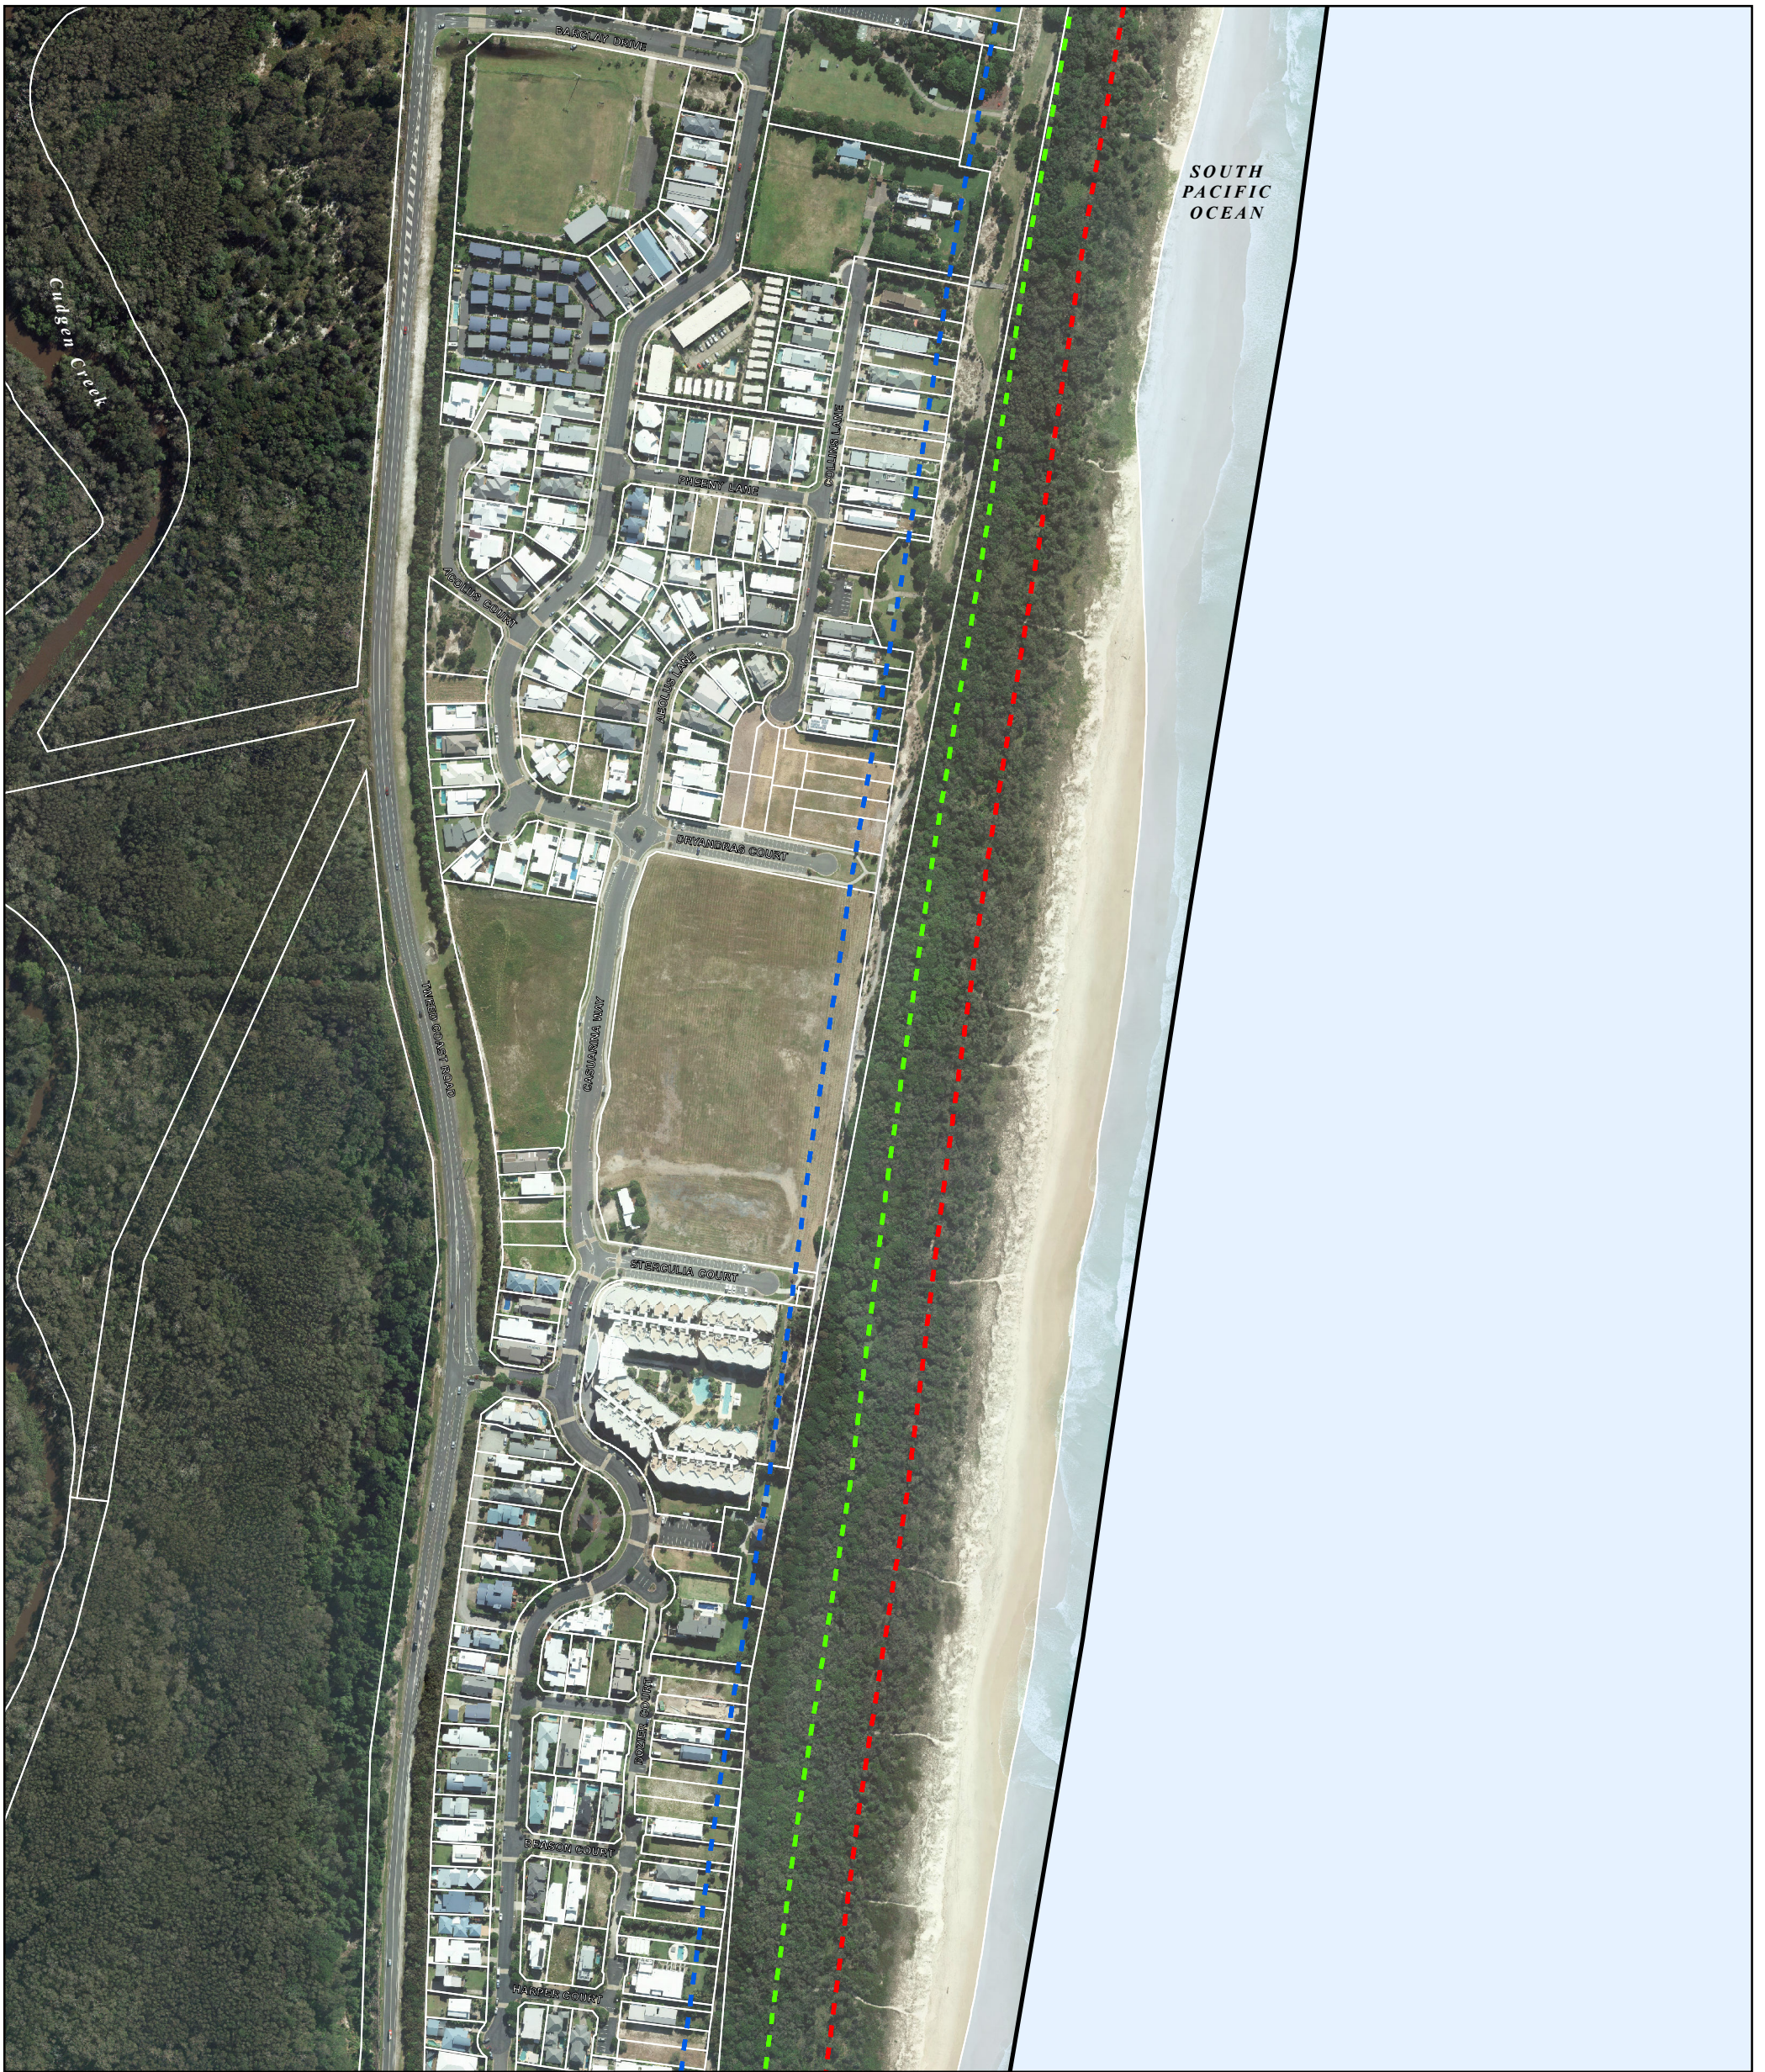
A zone of reduced bearing capacity will exist landward of a receding erosion scarp. Definition of the extent of the zone of reduced bearing capacity will require professional assessment on a site by site basis. An additional allowance in this regard should be included in considering the immediate hazard zone.

The accuracy of predicting these hazard lines is subject to many uncertainties. The existence of bedrock, indurated sands and/or structures may impact on the realisation of the hazards.

Coastal features and structures have been observed and digitally plotted using photogrammetric techniques. Hazard lines have been determined and plotted relative to the photogrammetry data. Cadastral boundaries as shown may not have been survey corrected and are presented for guidance.
