Tweed Waterways Report 2020

Connected by water:
Through the landscape and time

Water quality report card scores

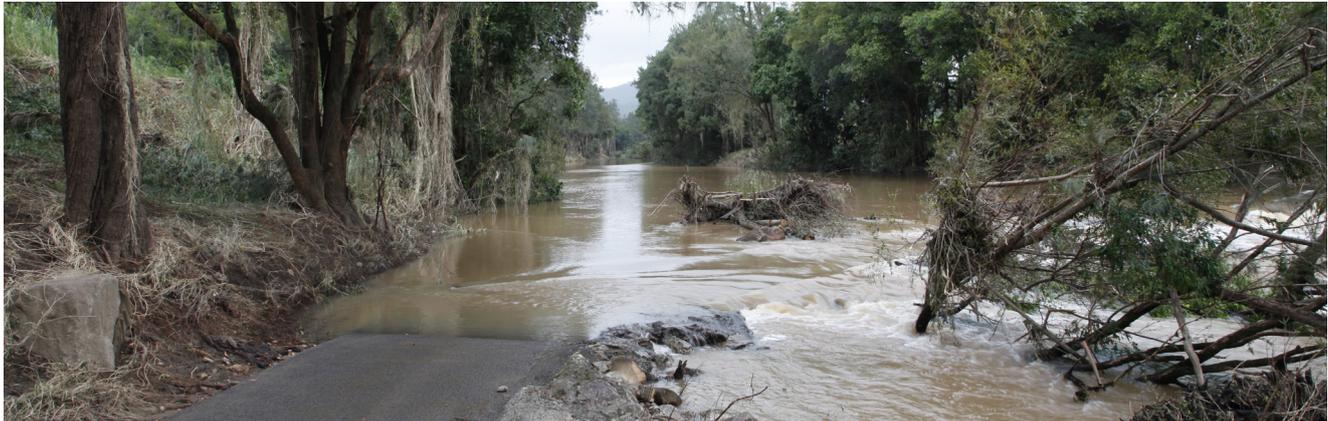
Murwillumbah rainfall statistics

Influence of rainfall on Tweed's 2019-2020 monitoring results

Whilst the Tweed Shire experienced the worst drought in recorded history during the early months of the 2019-2020 monitoring period (May 2019-April 2020), the total annual rainfall recorded was 1452.5mm, which is 92% of the shire's long-term average annual rainfall of 1583.6mm.

On a monthly scale, January and February (2020) were the only months where the long-term monthly averages were exceeded and the combined total rainfall for these two months accounted for 66% of total annual rainfall.

Almost half (48%) of the total annual rainfall was received in February, alone, during a significant flood event. Because the testing period for this report is short, the water quality scores are more significantly influenced by a single large flood event than if it were for a long-term monitoring program.

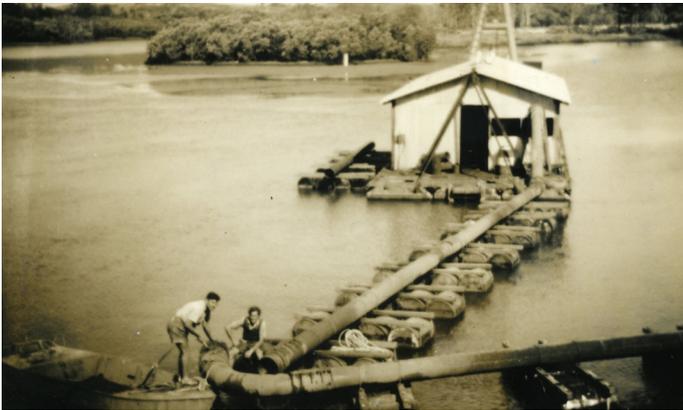
Dredging to allow cane & banana transport boats access (1950's)

Dredge working in Terranora Inlet opposite Pioneer Park, where the building for Tweed Heads Historical Society stands.

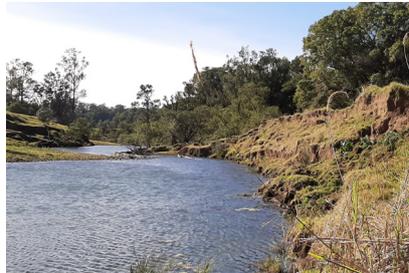
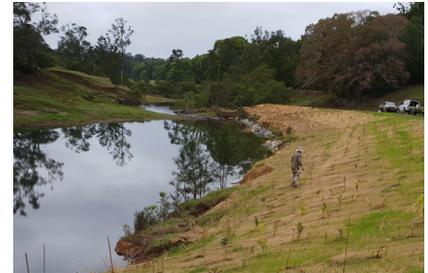
- The reduction of bank erosion, agricultural run-off and stock access to waterways are central themes to a number of projects that Council, in collaboration with private landholders, are addressing in the Upper Catchments via the [River Health Grants Program](#).

Before

After

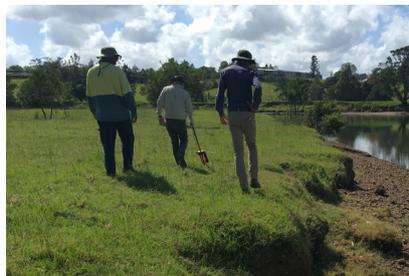
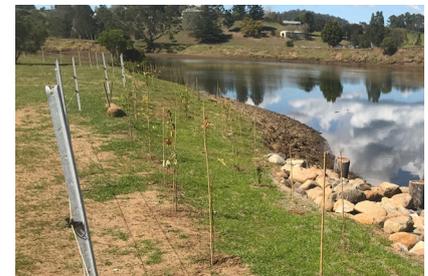
- Council's Waterways Management team recently collaborated with private landholders, local bush regenerators and the Tweed chapter of [OzFish Unlimited](#) to complete a combination of river bank stabilisation works, riparian revegetation, cattle exclusion fencing and fish habitat creation in the Tweed Upper Estuary.

Before

After

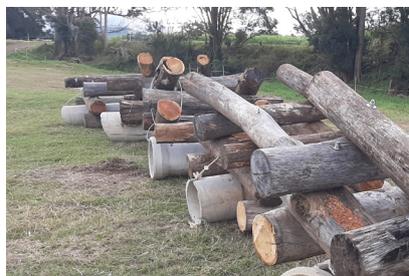
Fish hotel structures

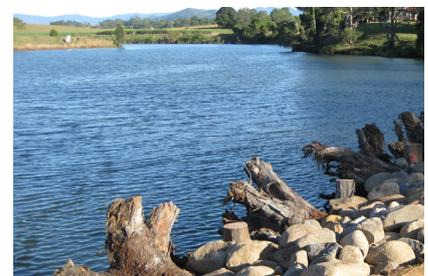
Recycled tree stumps as fish habitat

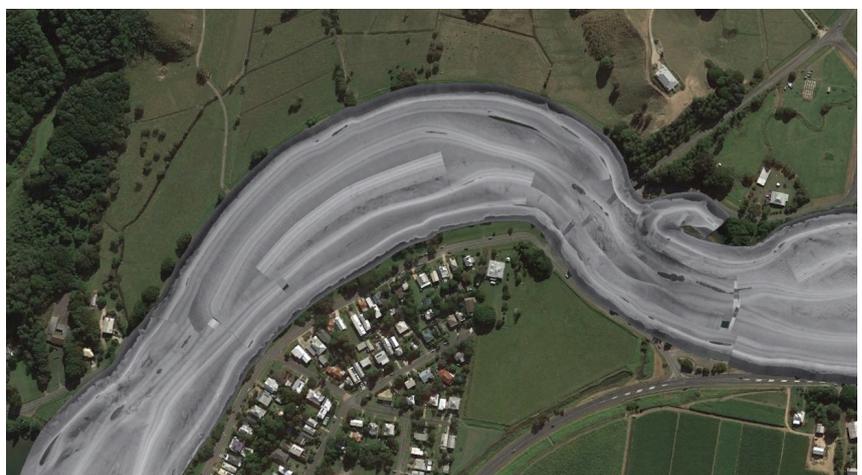
- In the Tweed Mid Estuary, fish habitat mapping has been undertaken, using side-scan sonar, to assess the quantity and diversity of fish habitat material. This information will allow Council to incorporate a diverse range of fish habitat, for enhanced ecosystem function and visual amenity of the river, when planning future river bank stabilisation projects.

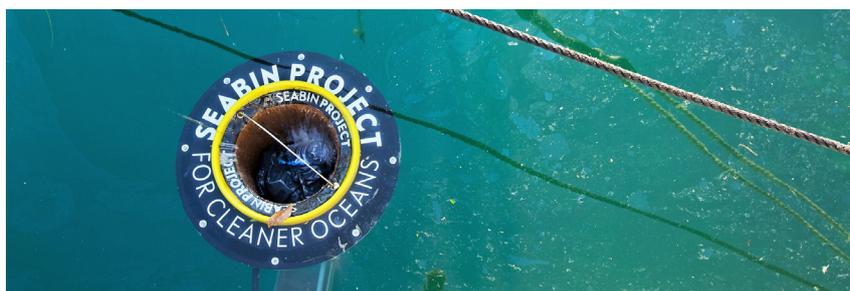
- In March 2020, Council installed a [SeaBin](#) 'trash skimmer' at the Tweed Heads Marina to help address the issue of plastic debris entering estuary and marine environments.
