Coastal Hazard Lines Map
 Figure 1.21
 Sheet 21 of 26

TWEED DEVELOPMENT CONTROL PLAN
 Section B25
 Coastal Hazards

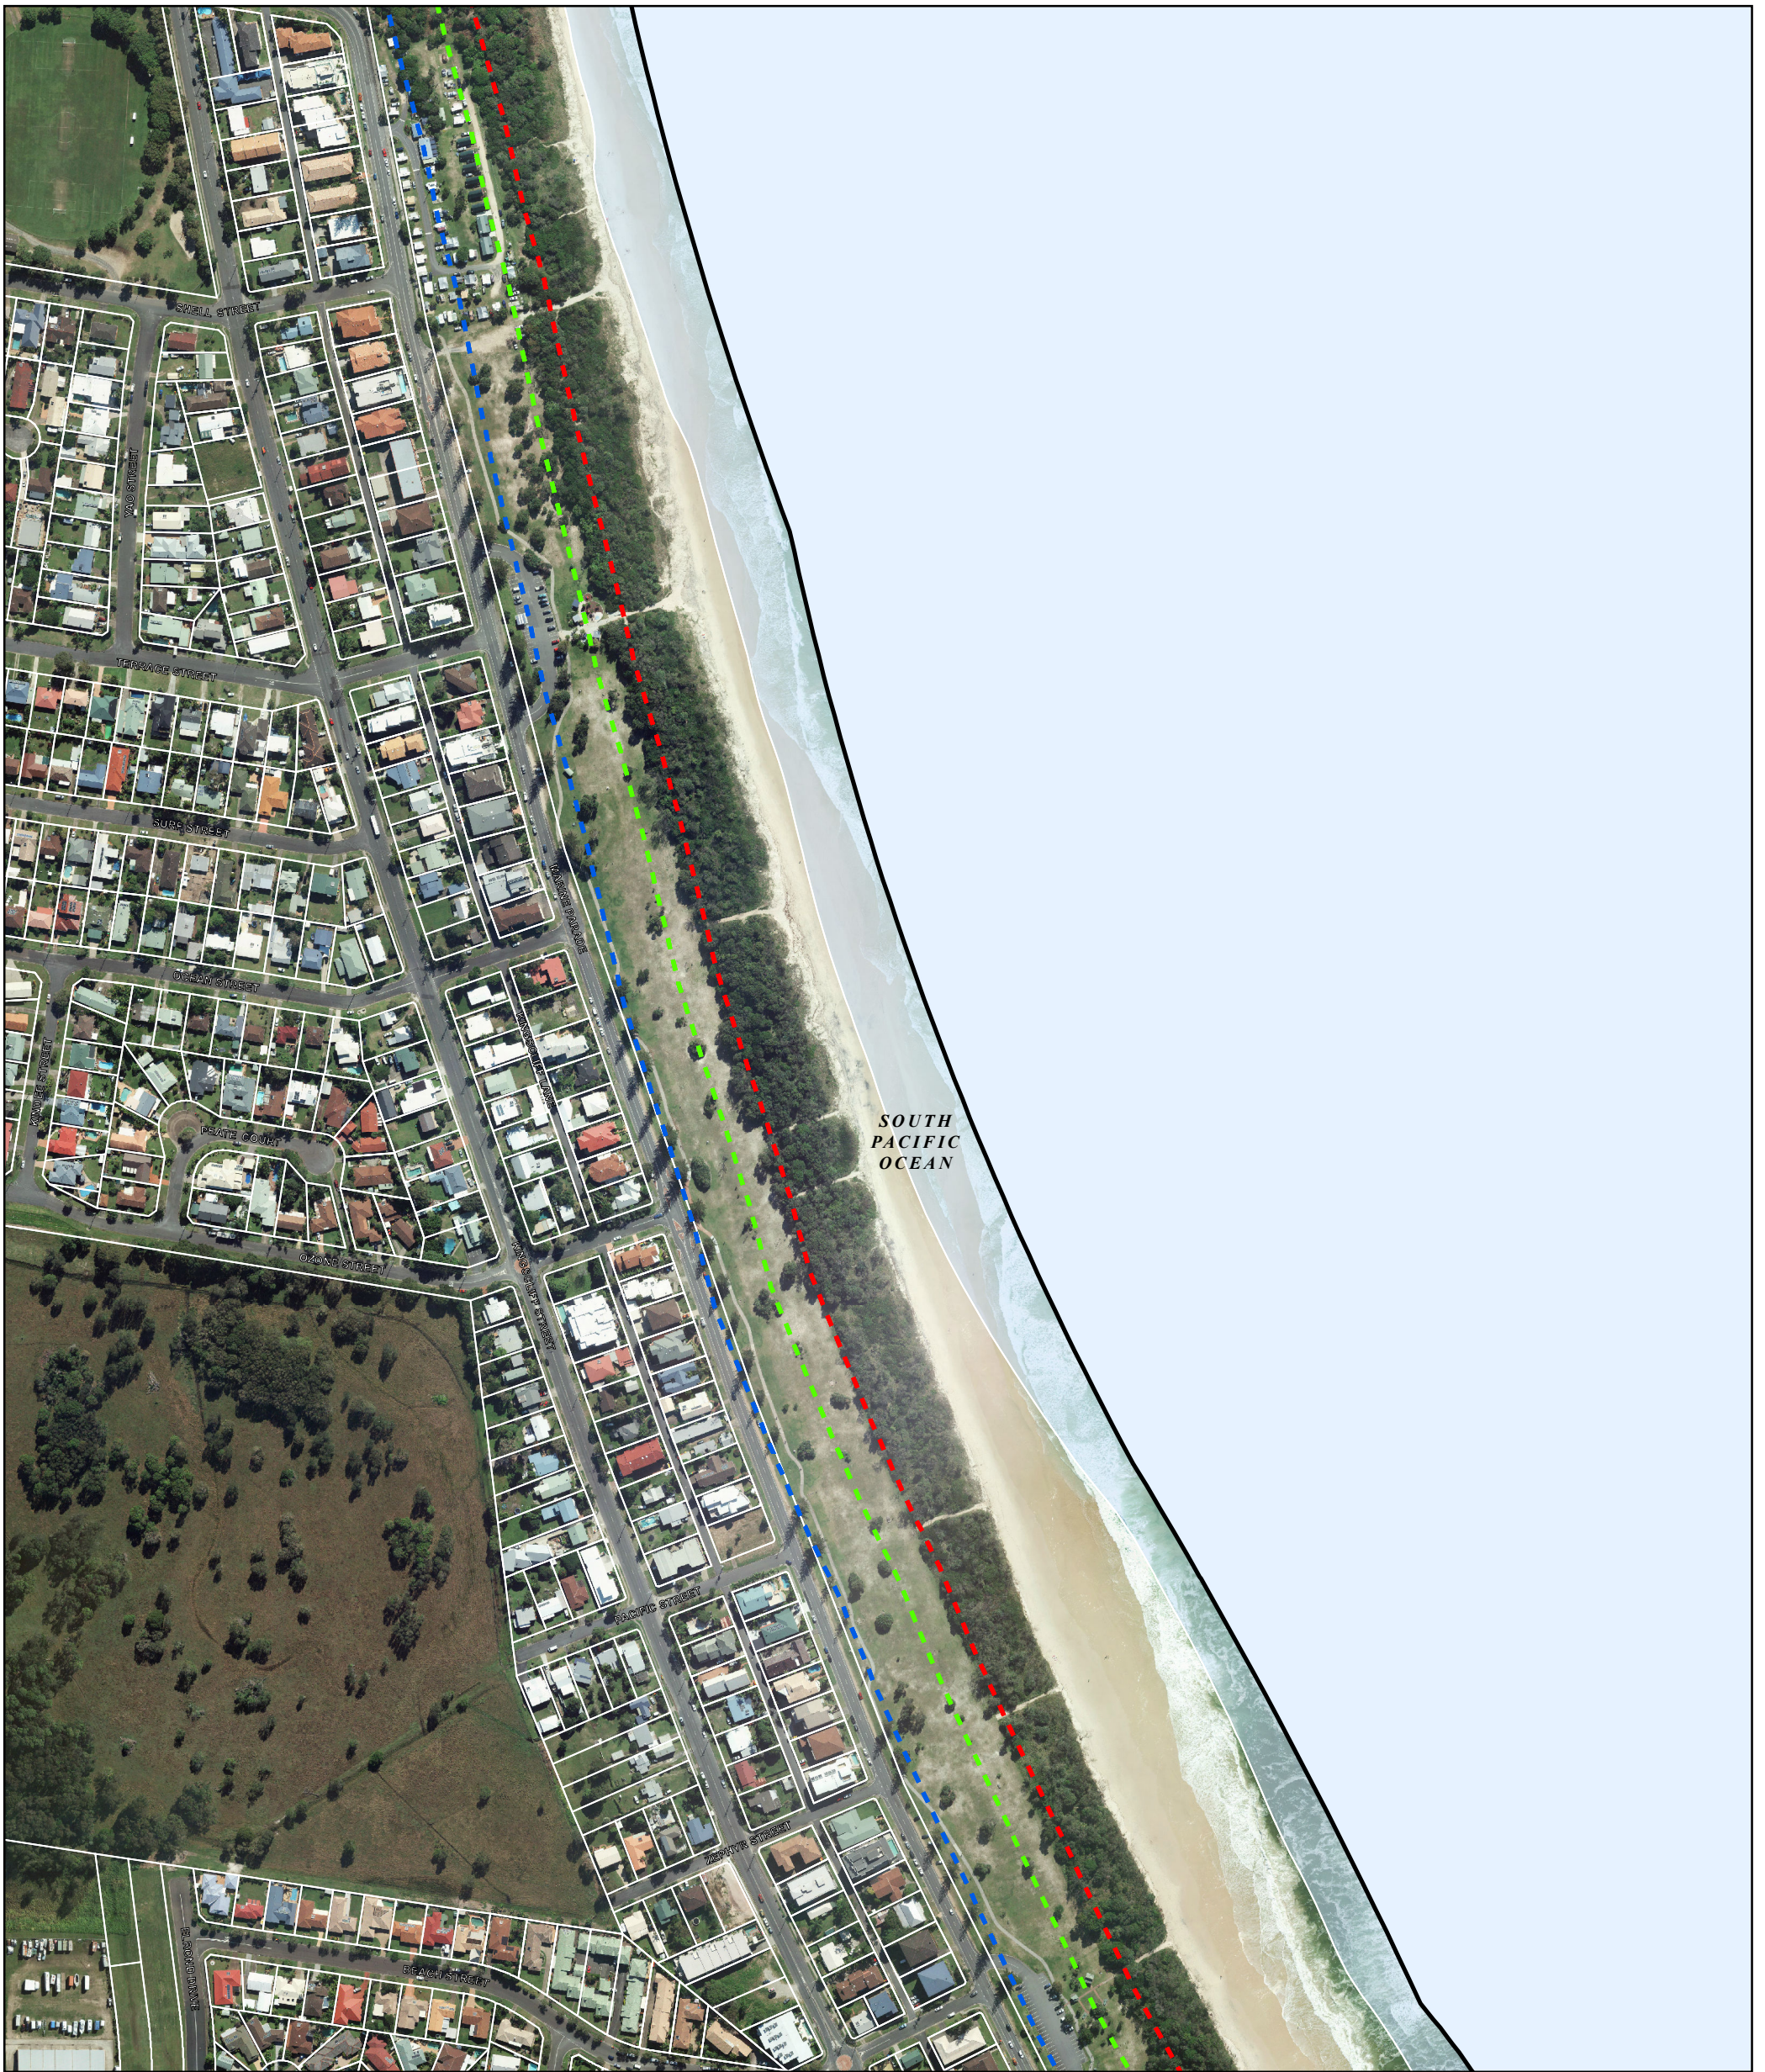
The accuracy of predicting these hazard lines is subject to many uncertainties. The existence of bedrock, indurated sands and/or structures may impact on the realisation of the hazards.

Coastal features and structures have been observed and digitally plotted using photogrammetric techniques. Hazard lines have been determined and plotted relative to the photogrammetry data. Cadastral boundaries as shown may not have been survey corrected and are presented for guidance.
